Old Santa Fe Railroad Depot (Old Depot Museum)

Exterior Damage to Terne Metal Roof

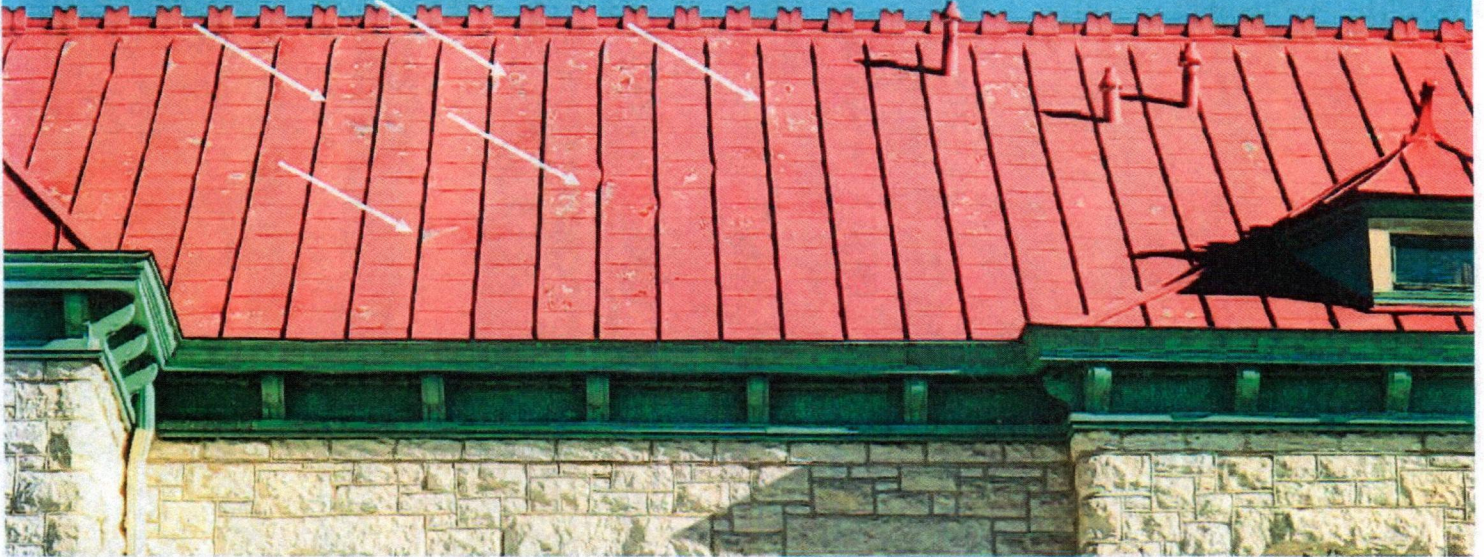
The discolored patches are places where the metal has lost all of its coating and is completely bare.

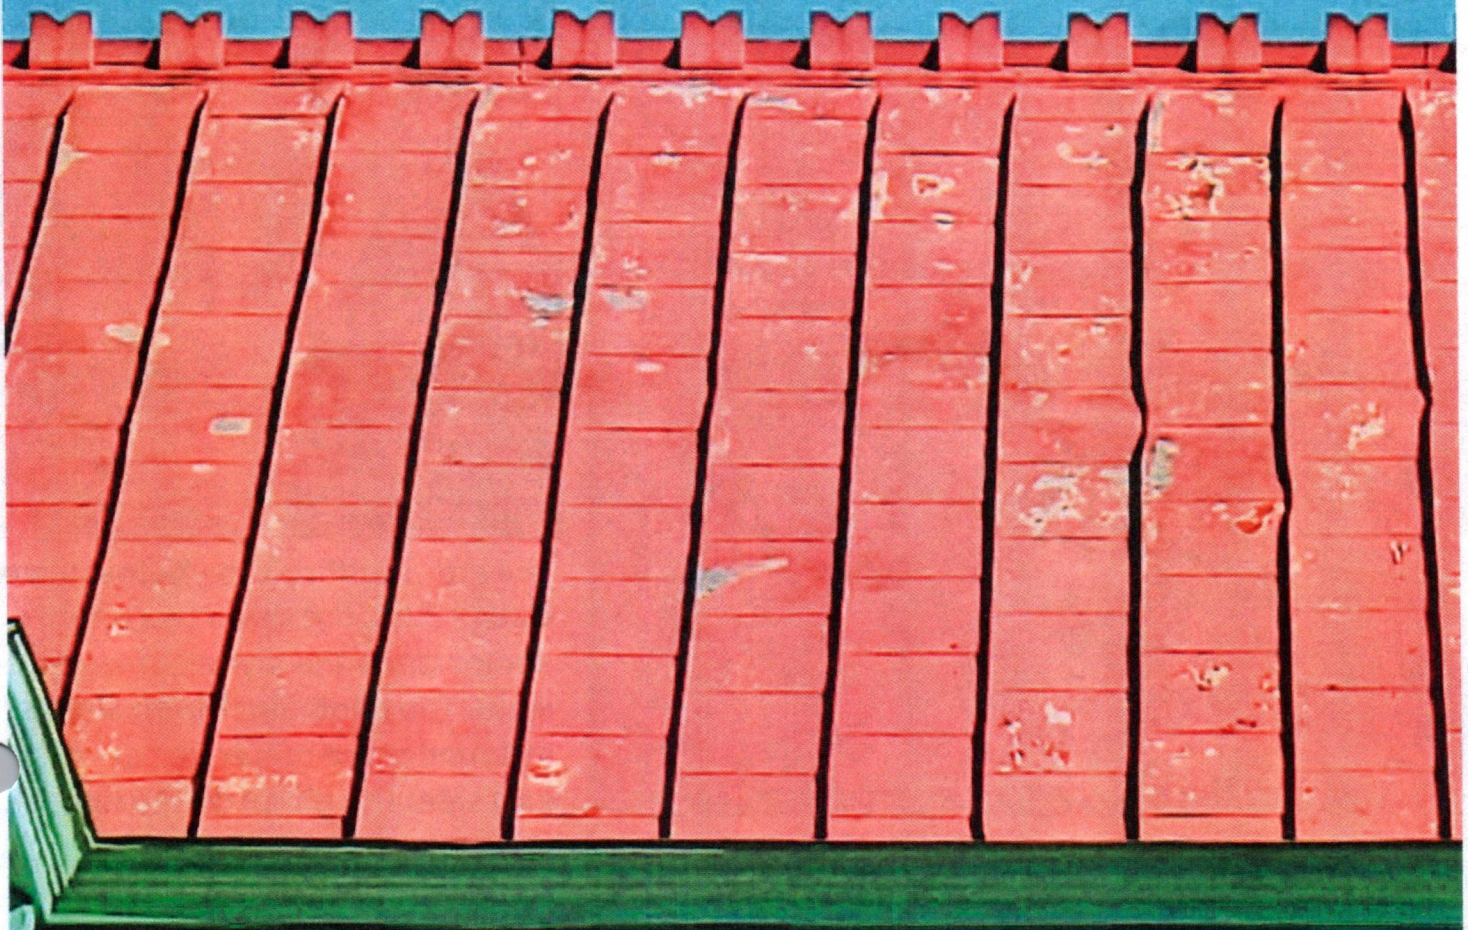
Closer view of the discolored patches where the coating has been lost.

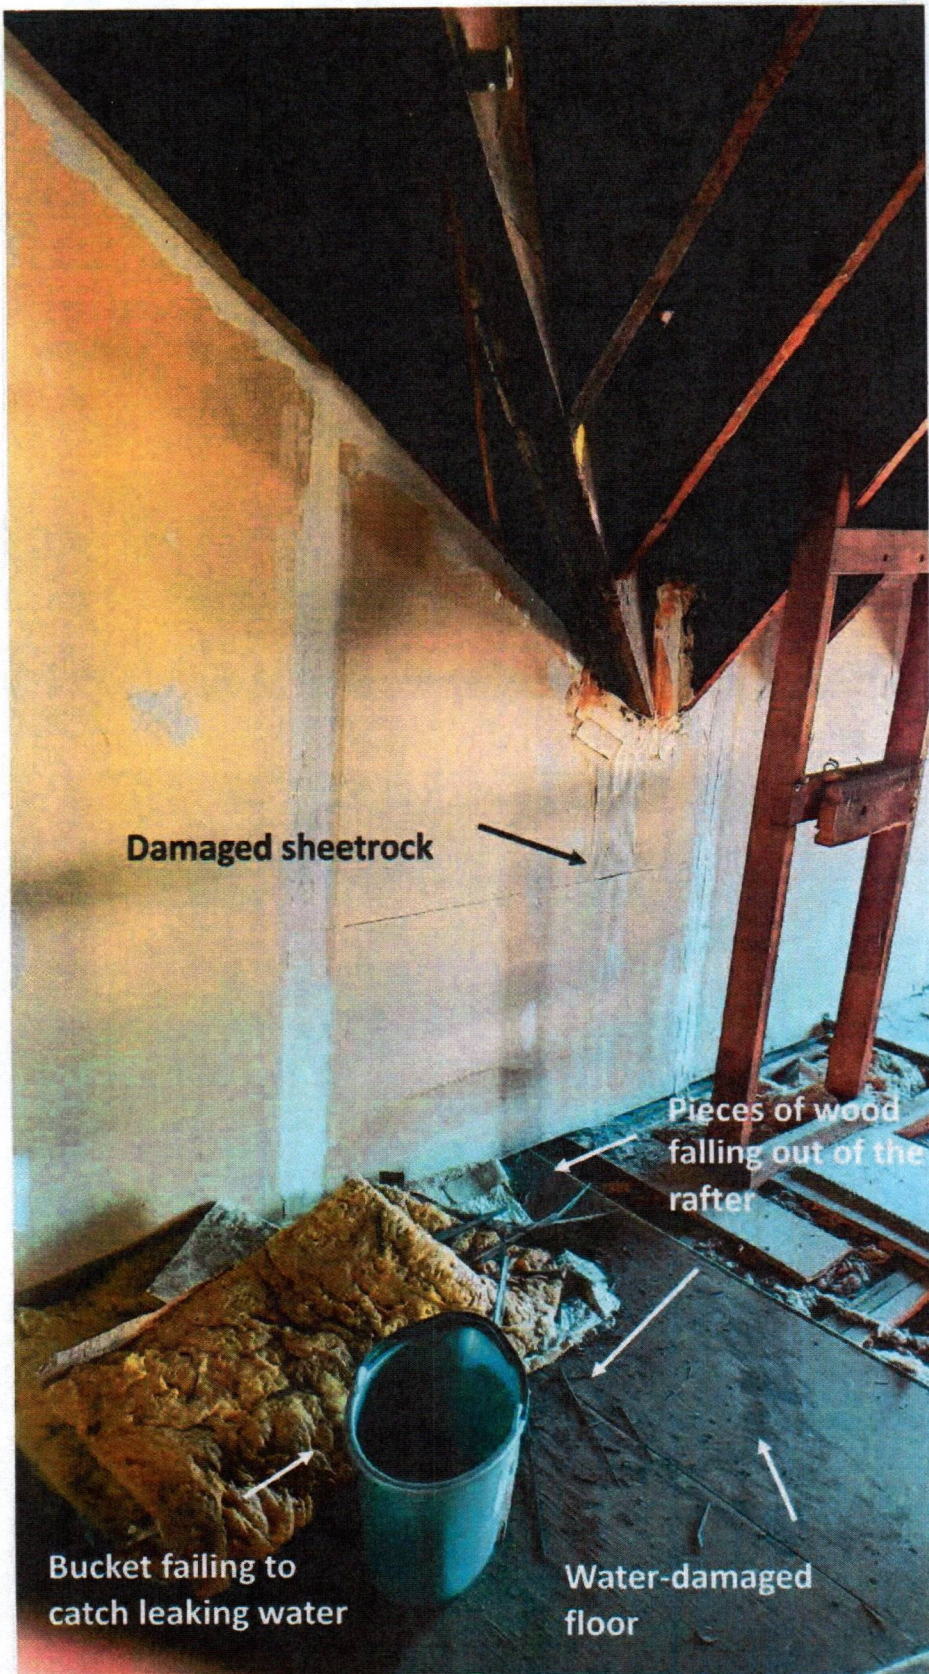
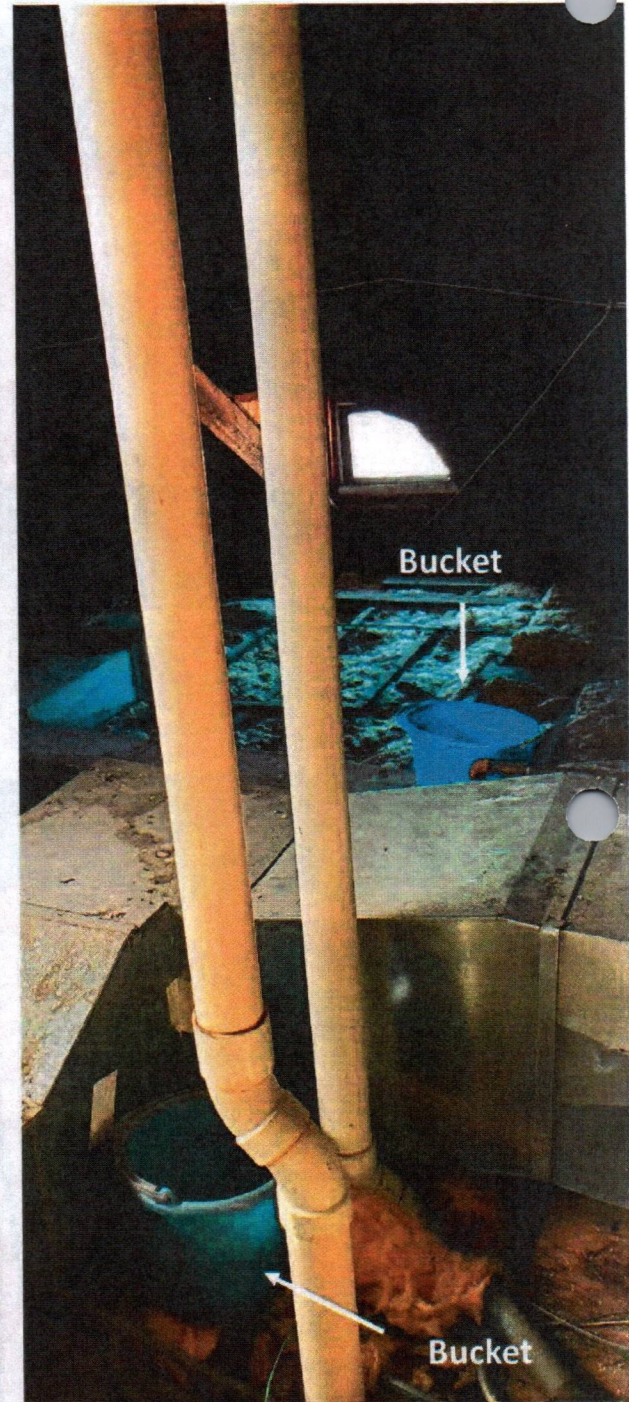
Attic above second floor

The attic is difficult to photograph on cloudy days, but these two photos demonstrate the myriad of water leaks. The photo on the left shows the attic under the center dormer on the east side. The photo on the right shows the HVAC unit near the southwest dormer.

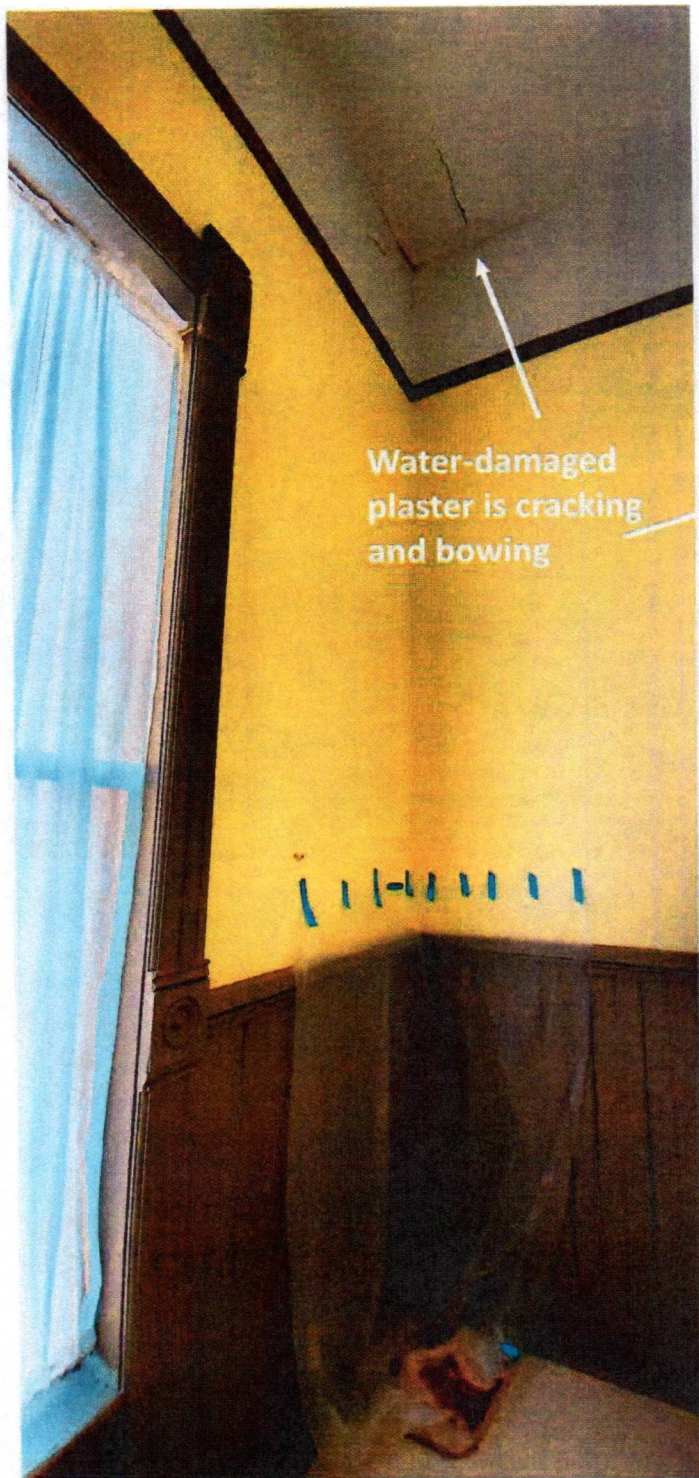
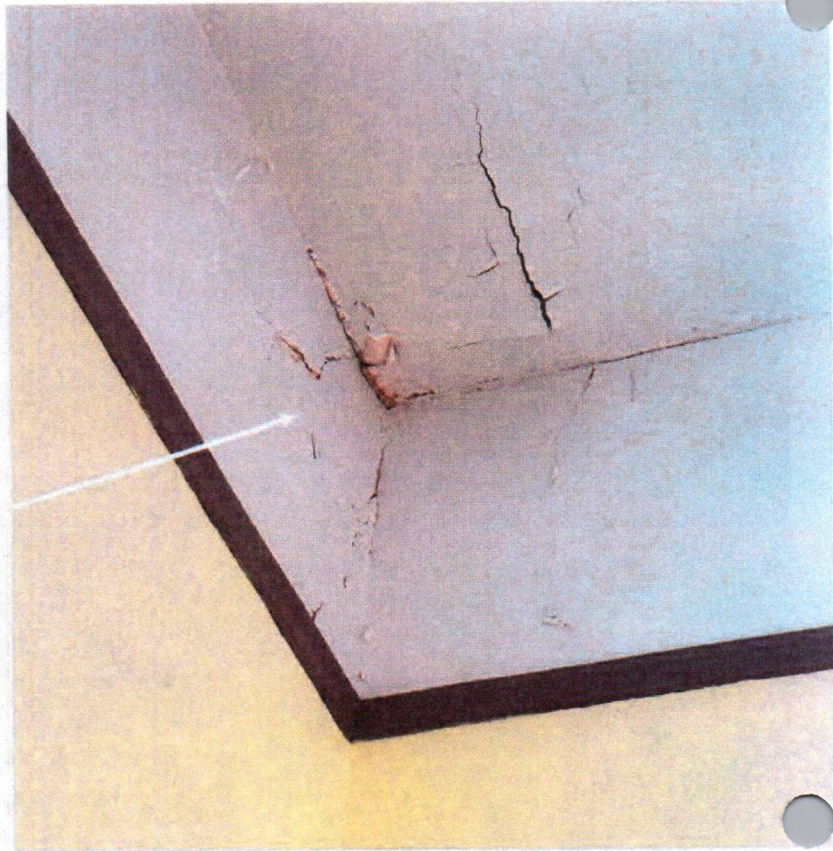
Soda Fountain Room, second floor

This corner leaks with nearly every rain. The damaged area on the ceiling is approximately 3 feet by 3 feet. We have taped painter's plastic to the walls to protect the woodwork. The plastic sheets drain into a plastic tub. Note the brown water in the tub. (We normally hide this behind a small folding screen.) All of the photos that were once displayed in this area have been removed to prevent damage.

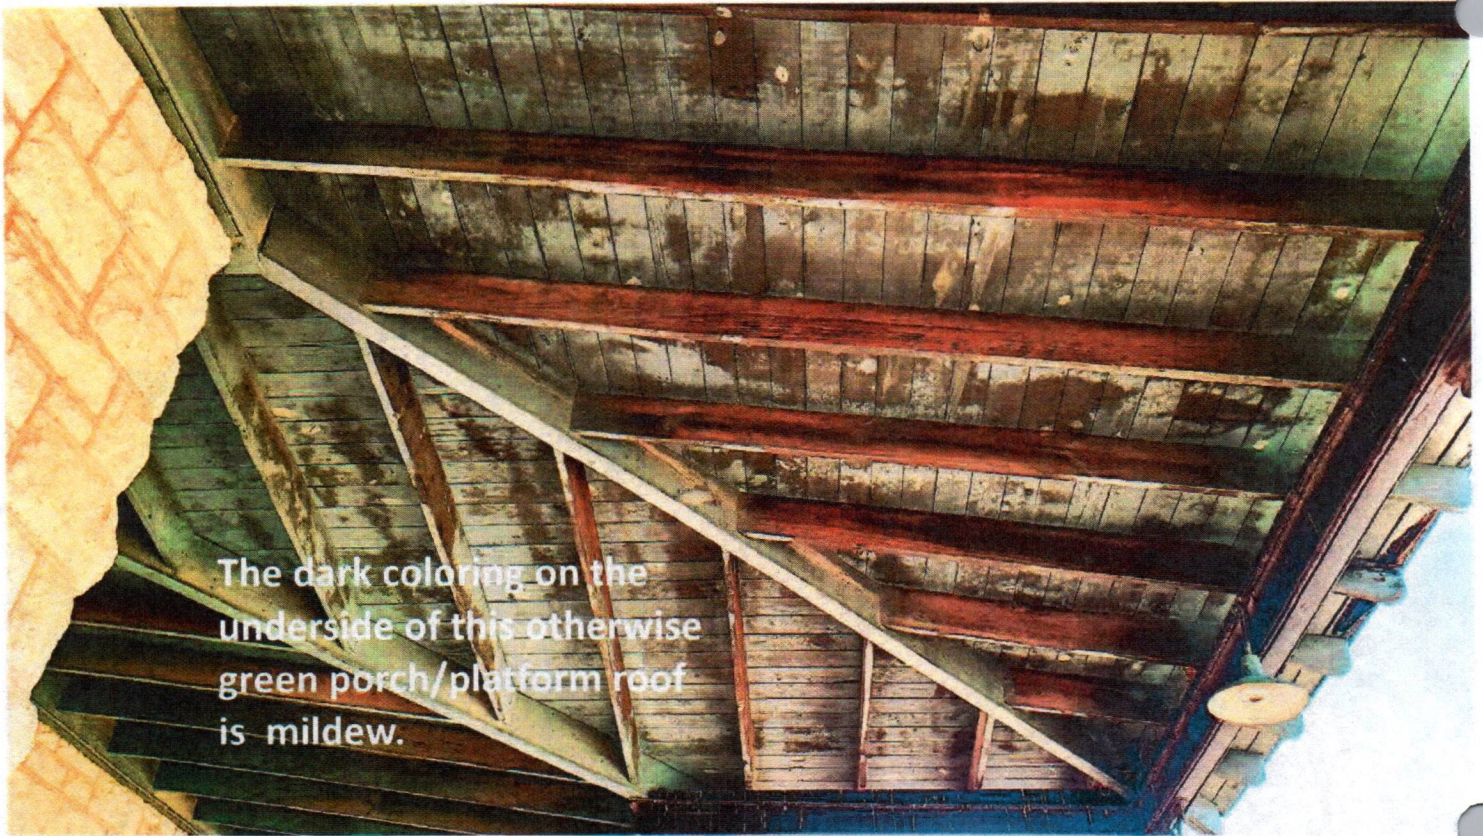
The dark coloring on the underside of this otherwise green porch/platform roof is mildew.

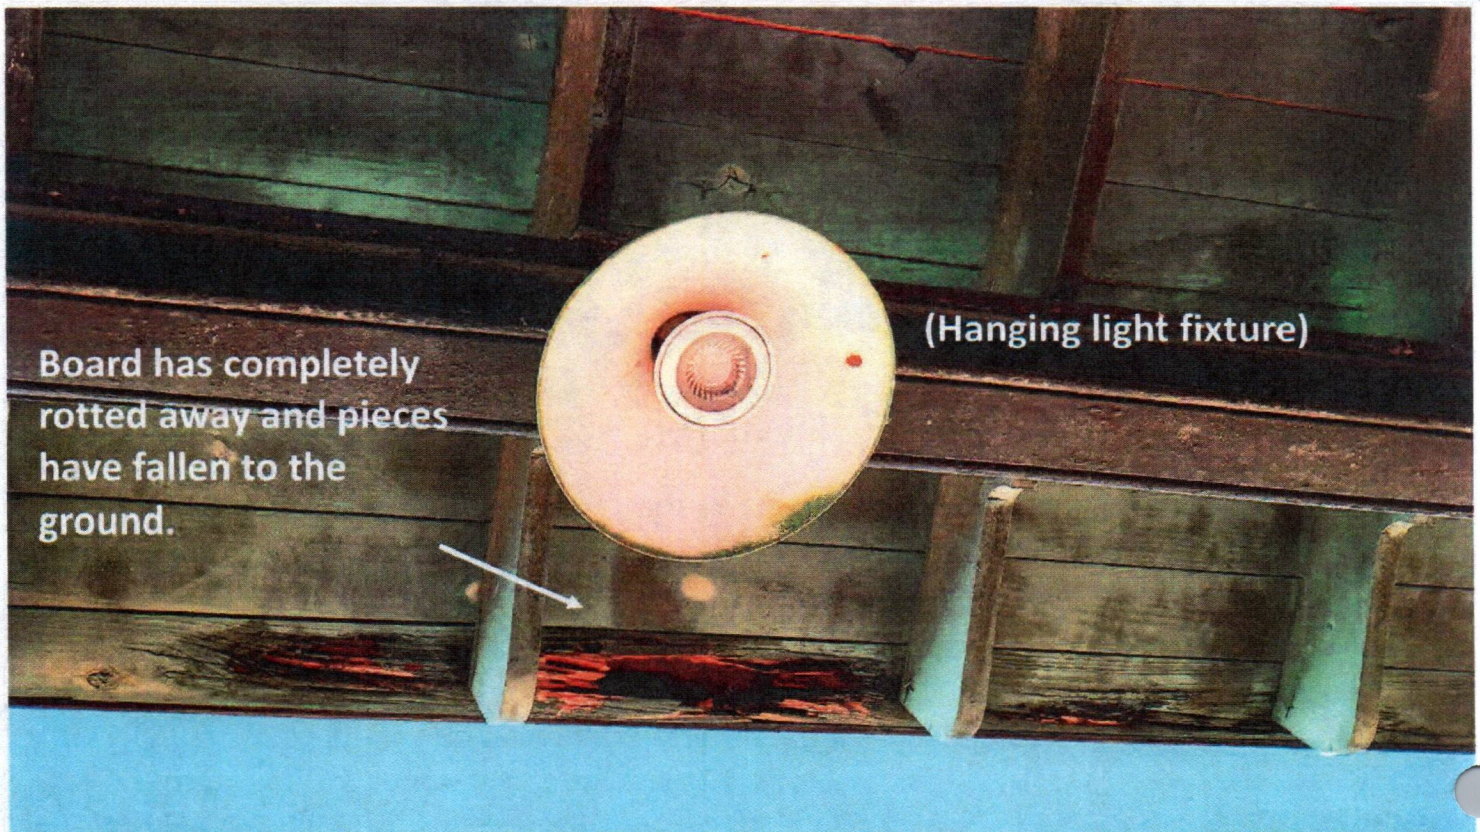
(Hanging light fixture)

Board has completely rotted away and pieces have fallen to the ground.

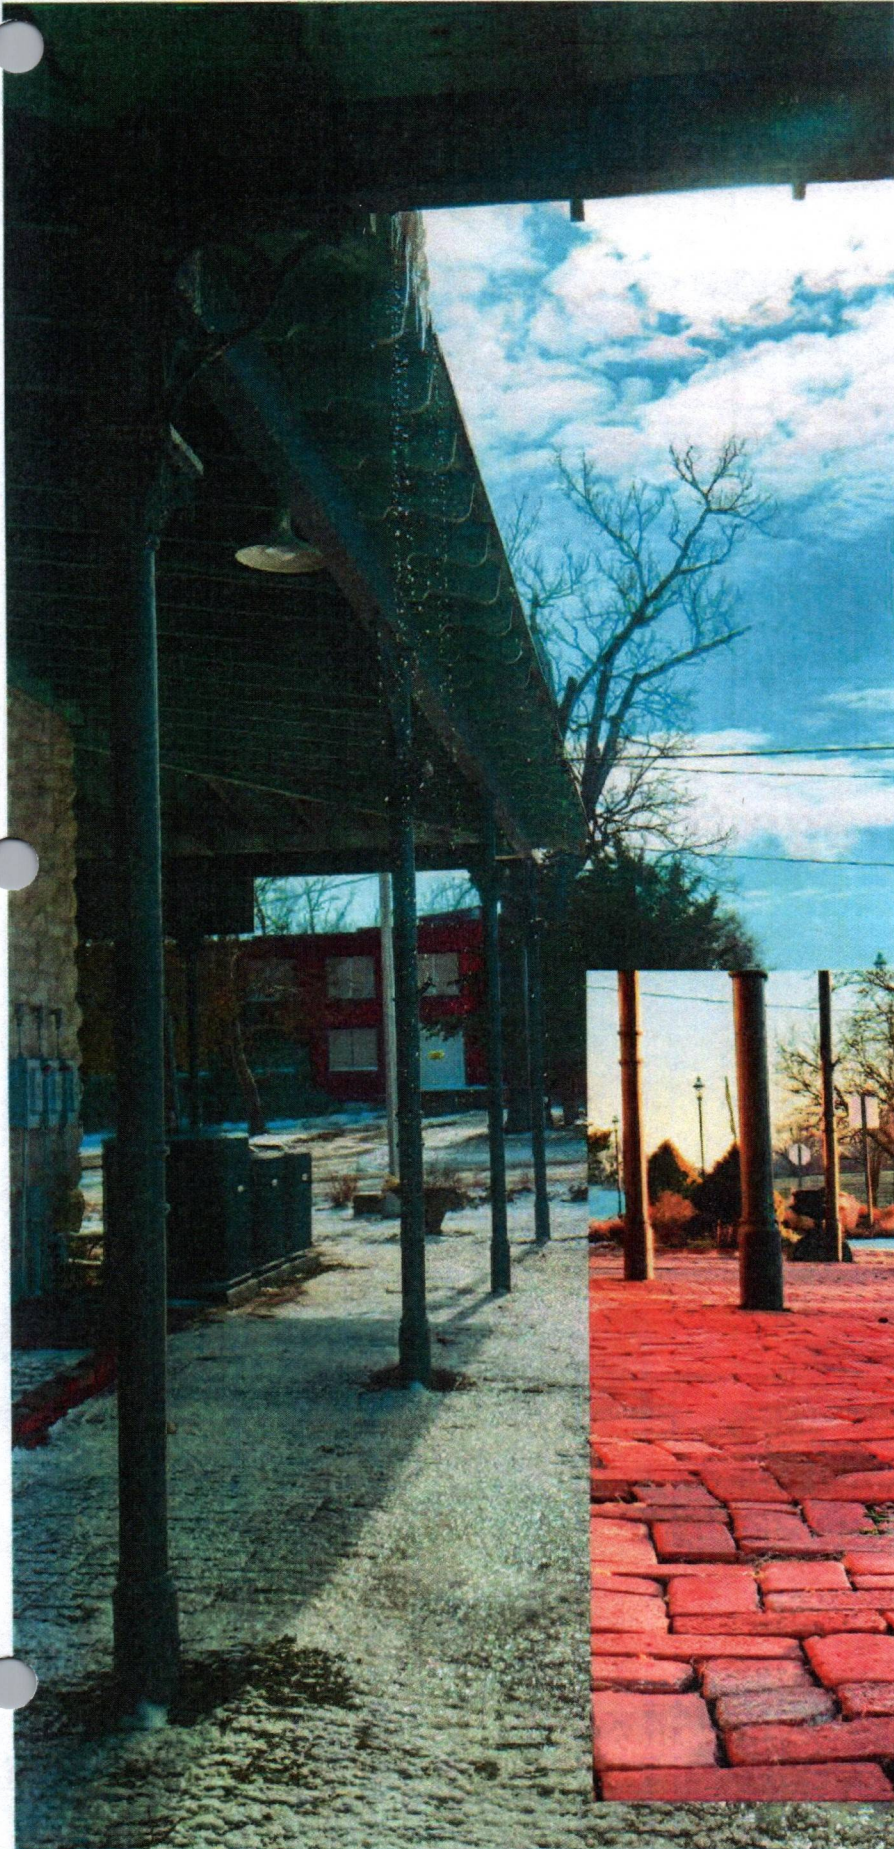
This winter photo shows how the water drips straight down the edge of the roof instead of away from the roofline. Some of the water wicks into the woodwork, and the rest pounds into the bricks below, causing damage to the bricks (see photo below).
